# STRESS CORROSION CRACKING OF TITANIUM ALLOYS

PROGRESS REPORT: OCTOBER 1 - DECEMBER 31, 1964

S. P. Rideout, M. R. Louthan, Jr., and C. L. Selby

**Savannah River Laboratory**  
**Aiken, South Carolina**

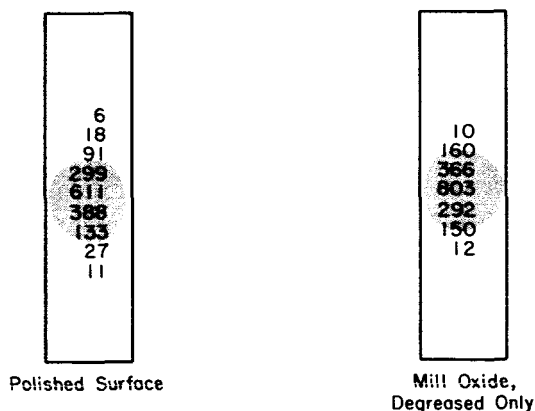
FIG. 2 DISTRIBUTION OF  $^{36}\text{Cl}$  ACTIVITY (COUNTS PER MINUTE) ON SAMPLES EXPOSED TO SATURATED  $\text{NaCl}$  SOLUTION AT ROOM TEMPERATURE FOR 15 MINUTES. Drops of the solution were applied (shaded areas) and then washed off with hot water prior to counting.

The tests demonstrated that chloride ions were very readily adsorbed on the surface of samples at room temperature and could not be washed off. On samples heated at 250 and 650°F, the chloride ions were apparently absorbed into the oxide film. The chloride ions were distributed fairly uniformly in the area of initial contact. Significant amounts of sodium were retained only on heated samples at spots where solid  $\text{NaCl}$  adhered to the metal or where salt-metal corrosion occurred. Attempts to show chloride or sodium concentrations in cracks by autoradiography were unsuccessful. Results are discussed in detail below.

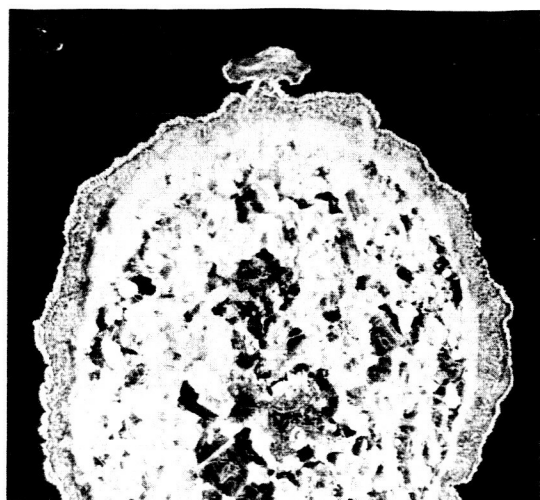
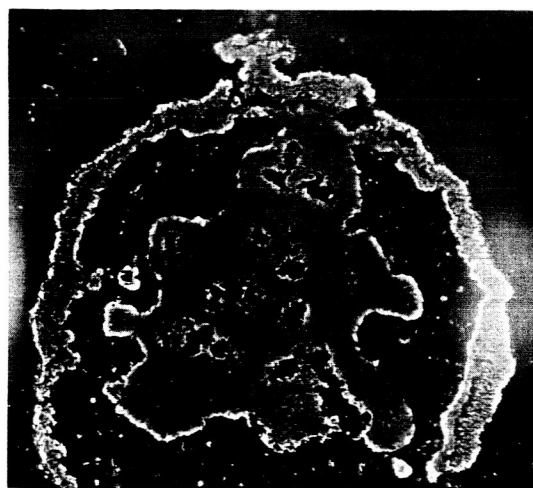
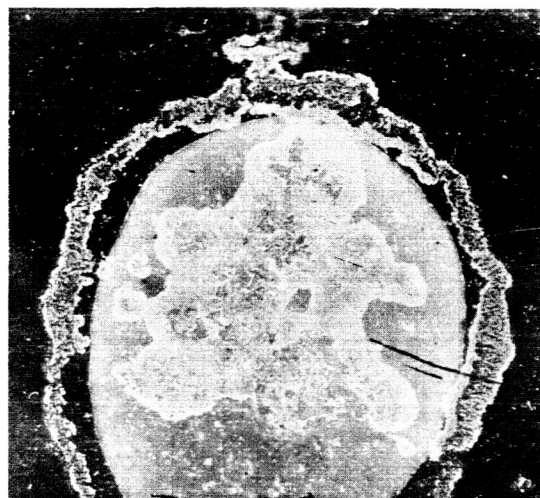
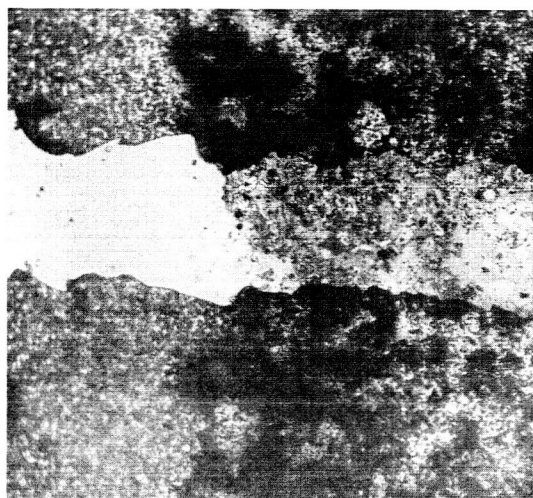
a. Salt before rinsing (4X)

b. After rinsing (4X)

c. Autoradiograph in situ (4X)

d. High magnification view of  
autoradiograph with emulsion  
partially removed to reveal metal  
surface. (200X)

Autoradiography was used to determine the distribution of  $^{36}\text{Cl}$  and  $^{22}\text{Na}$  on prepolished and stressed samples exposed with salt deposits at  $650^\circ\text{F}$  for 3 days. The salt deposits were produced by evaporating drops of saturated solution on the sample surfaces. After exposures the salt deposits were rinsed off and the samples were coated with a liquid photographic emulsion sensitive to beta radiation. The emulsions were dried, exposed, and developed in situ. Figure 3 illustrates this sequence on a sample exposed to  $\text{Na}^{36}\text{Cl}$ . The area covered by the salt deposit before and after the salt was rinsed off is shown in Figures 3a and 3b, respectively. During evaporation of the saturated solution, a fringe of fine crystals formed around the circumference of the deposit as a result of efflorescence. As shown in Figure 3a, the final deposit contained a wide range of crystal sizes. Figure 3b shows some  $\text{Na}^{36}\text{Cl}$

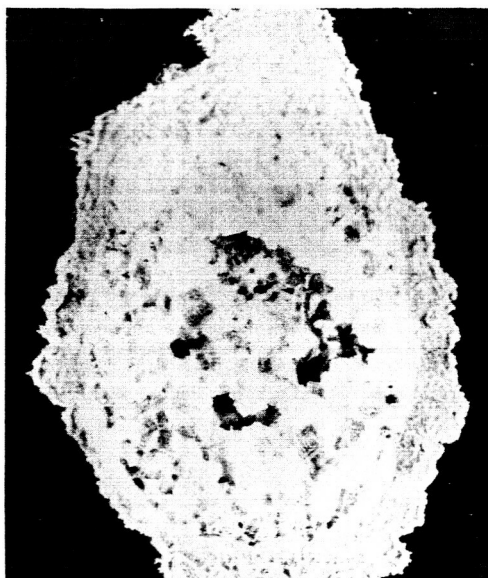
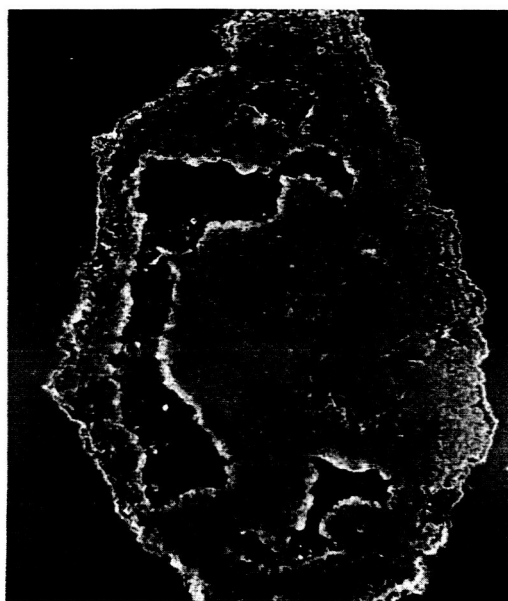
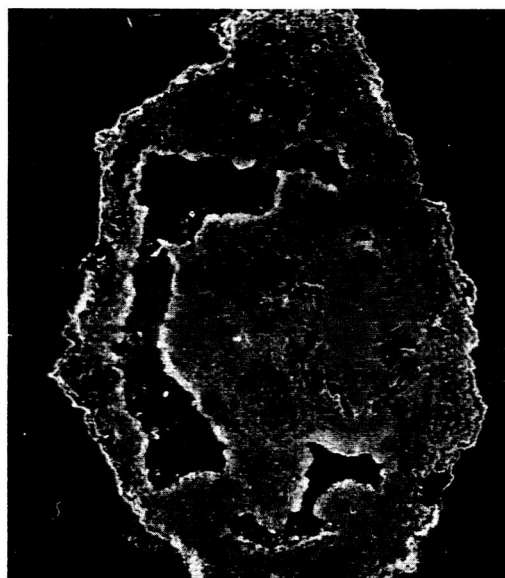
a. Salt before rinsing

b. After rinsing

c. Autoradiograph in situ

FIG. 4 Ti-8Al-1Mo-1V EXPOSED TO  $^{22}\text{NaCl}$  FOR 3 DAYS AT  $650^\circ\text{F}$ .  
 Autoradiographic emulsion (c) was exposed 7 days.  $^{22}\text{Na}$  was present only where  
 residual  $^{22}\text{NaCl}$  adhered. (4X)

Autoradiographs of samples exposed to  $^{22}\text{NaCl}$  showed that sodium was present only in those spots where  $\text{NaCl}$  adhered to the surface, as shown in Figure 4.

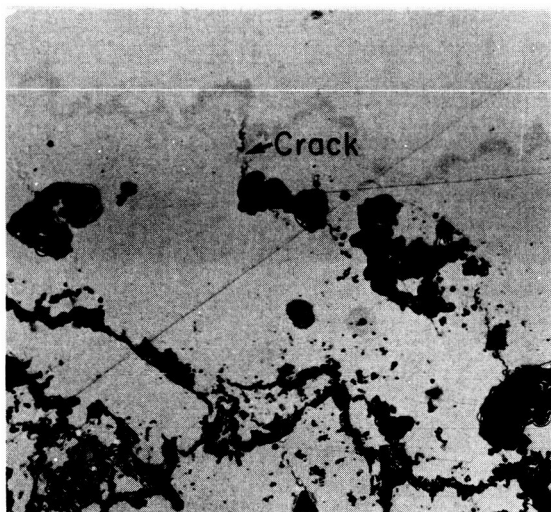
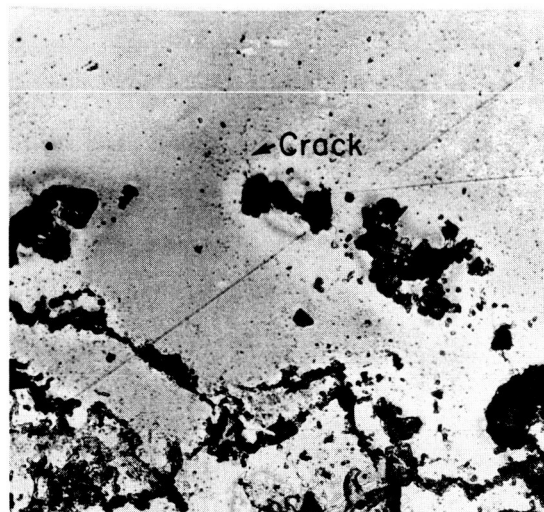
a. Before autoradiography

b. Autoradiograph in situ

FIG. 5 MICROCRACK IN Ti-8Al-1Mo-1V EXPOSED TO  $\text{Na}^{36}\text{Cl}$  3 DAYS AT  $650^\circ\text{F}$ . Emulsion exposed only one day. No preferential darkening of emulsion around crack. (150X)

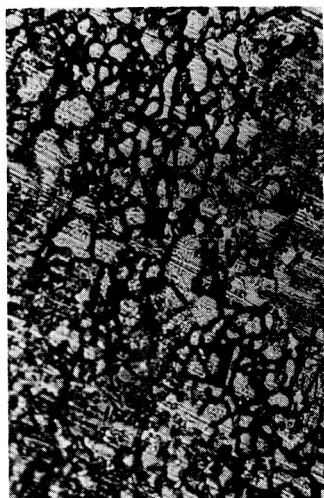
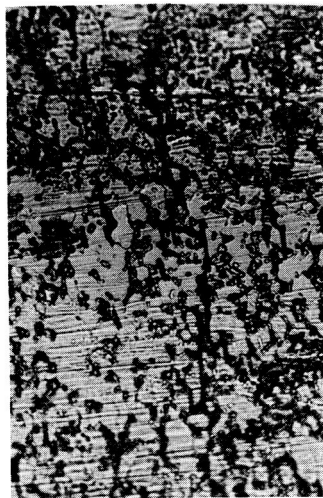
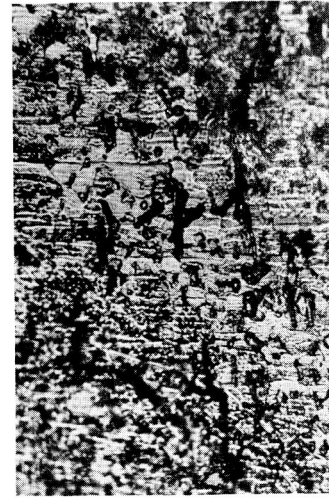
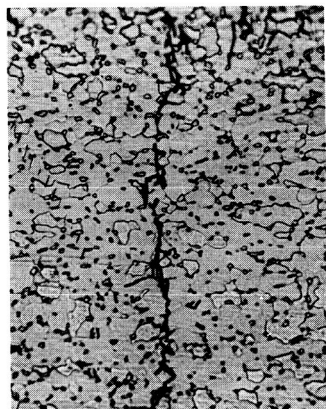
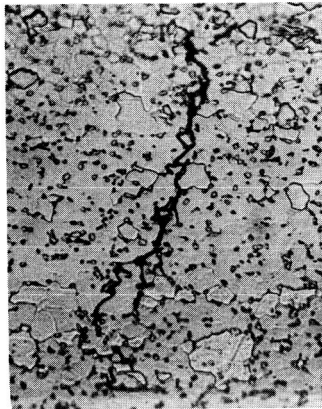
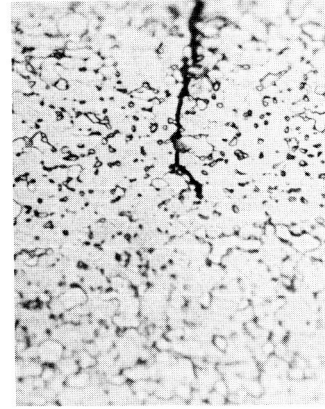
a. Surface view (salt removed from surface and specimens examined)

b. Transverse view (specimens sectioned, polished, and etched)

FIG. 6 HOT-SALT CRACKING OF Ti-8Al-1Mo-1V ALLOY BY VARIOUS HALIDE SALTS. Samples were exposed for 72 hours at 650°F. (425X)

Tests performed during this quarter demonstrated that NaCl is not unique in causing stress corrosion cracking of titanium alloys. Deposits of NaI and NaBr both produced cracking. Polished samples of duplex-annealed Ti-8Al-1Mo-1V alloy stressed in three-point loading jigs were exposed with deposits of NaI, NaBr, and NaCl for 3 days at 650°F. The samples were exposed in the same muffle furnace together with a control sample having no salt deposit. Metallographic examination of the surfaces after removal of the salts revealed intergranular cracking on all samples except the unsalted control. Cracking caused by the NaCl was most severe, as shown in Figure 6. Sectioning revealed crack depths as follows:

<u>Salt</u>	<u>Crack Depth, inch</u> <u>(3-day exposure at 650°F)</u>
NaCl	.006
NaBr	.003
NaI	.003
None(a)	No cracks
<hr/> (a) Control sample

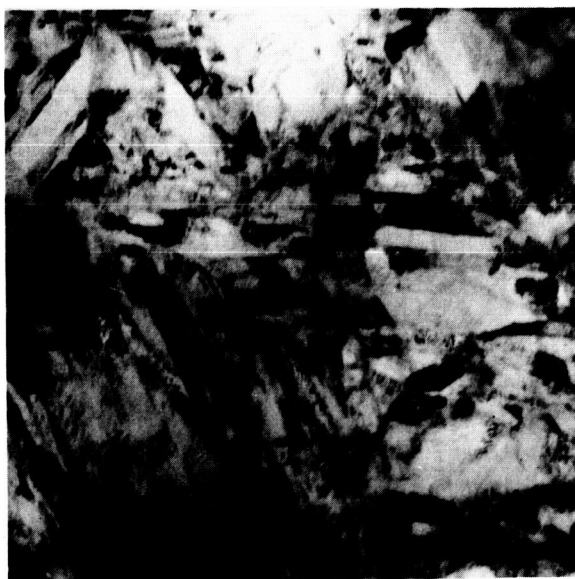
FIG. 7 SPOTTY CONTRAST IN TITANIUM FOIL RESULTING FROM TITANIUM HYDRIDE PRECIPITATION. (37,000X)

These studies revealed that spotty contrast (Figure 7) observed in many areas in the foils resulted from titanium hydride precipitation in certain regions. The hydride was identified by selected area electron diffraction.

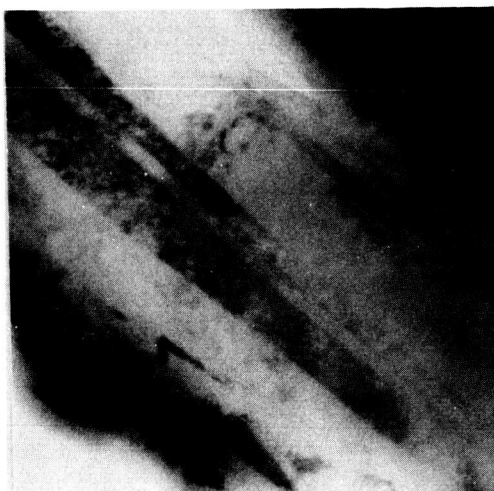
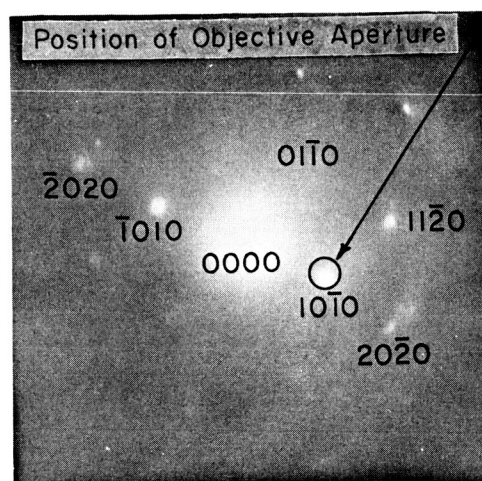
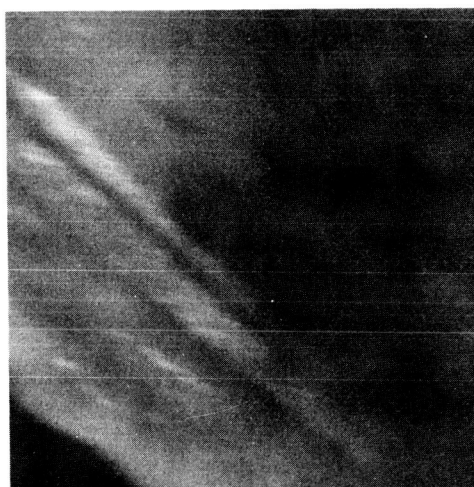
a. Bright field image (60,000X)

b. Selected area diffraction

c. Dark field image from  $(10\bar{1}0)$  plane. (60,000X)

FIG. 8 SERIES OF PHOTOMICROGRAPHS SHOWING PRECIPITATION OF TITANIUM HYDRIDE ON THE  $(10\bar{1}0)$  PLANE. Plane of the foil is  $(0002)$ .

- a. An area showing the hydride precipitate (Figure 8a) was selected.
- b. An electron diffraction pattern from that area was indexed (Figure 8b) showing that the  $(10\bar{1}0)$  plane gave maximum diffraction intensity.
- c. The area shown in Figure 8a was then viewed using the beam diffracted from the  $(10\bar{1}0)$  plane. The fact that the hydride precipitate was visible, but with reversed contrast, is proof that the hydride was on the  $(10\bar{1}0)$  plane. If the hydride were on some other plane, the contrast reversal would not be observed.

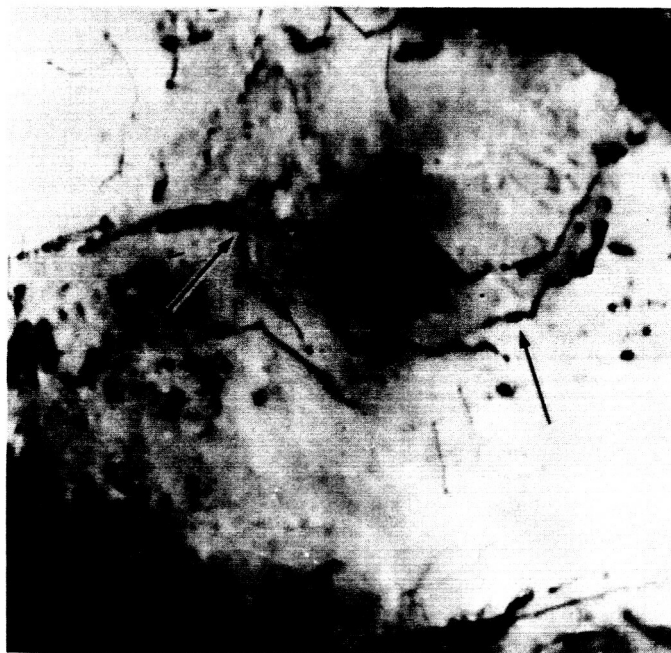
FIG. 9 ASSOCIATION OF A FINE PRECIPITATE WITH DISLOCATION. Arrows point to the phase which may be hydride phase. (50,000X)

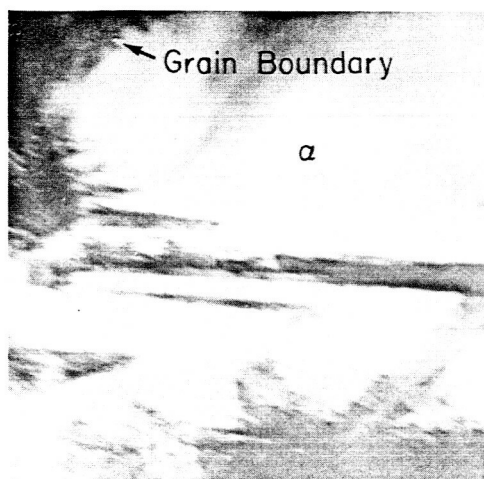
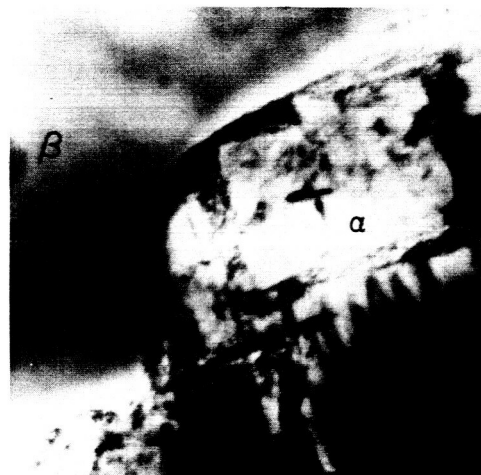
a. Hydride at grain boundary. Note the more or less continuous hydride precipitate along the boundary. (70,000X)

b. Hydride at  $\alpha$ - $\beta$  interface. Note the continuous nature of the hydride precipitate along the interface. (50,000X)

FIG. 10 PRECIPITATION OF THE HYDRIDE PHASE AT GRAIN BOUNDARIES AND ALPHA-BETA INTERFACES

The morphology of the hydride in the contaminated foils was such that most of the precipitation occurred in regions near alpha-beta phase boundaries (Figure 10a) and along  $\alpha$  grain boundaries (Figure 10b). This association may be due to a tendency for the hydrogen to enter the foil at such boundaries because of higher affinity for hydrogen in these regions. If one assumes that other interstitial impurities would behave similarly to hydrogen, then impurity segregation to grain boundaries would be expected. Such segregation should change the activity of the boundary and could be a contributing factor in the susceptibility to hot-salt cracking. Since the impurity segregation is generally enhanced by slow cooling rates, these results may have some bearing on the effect of cooling rate on the susceptibility to hot-salt cracking, described earlier in this report. Also if hydrogen embrittlement is involved in the cracking phenomena the affinity of the boundaries for hydrogen would explain why cracking is generally intergranular.
